# **Filtration of Harmonics in Lighting Fixtures**

The Sami Ofer Stadium in Haifa, which opened in 2014, is used for soccer matches of the Israeli national team, the Israeli League, and also for other events/cultural performances. A catwalk built along its stadium roof (largest of its type in Israel) has 200 lamps for field illumination. The fixtures are metal halide (MH) type, each consisting of a capacitor installed in its ballast to improve the power factor and reduce the operating current. The bulbs are high-intensity discharge (HID) type, which produce current harmonics, which were being amplified by the capacitors. The dominant harmonic created by these lamps is the fifth (250 Hz), and the total harmonic distortion in the current (THDi) exceeds 50%, resulting in frequent damage and unreliable operation. Figure 1 shows the waveform and spectrum of harmonics.

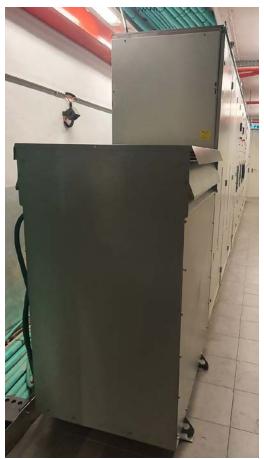
Figure 2 – Harmonic filter

The solution chosen and characterized by engineers Ariel Segal and Amir Broshi was a MIRUS International LINEATOR series passive harmonic filter. The filter was installed in the main electrical room (Fig. 2).
